Manhole Inspection Summary

Manhole # S23MM_042MH

Insp Date: **7/4/05 6:32 PM**

Location Address: **1501 RETREAT ST**

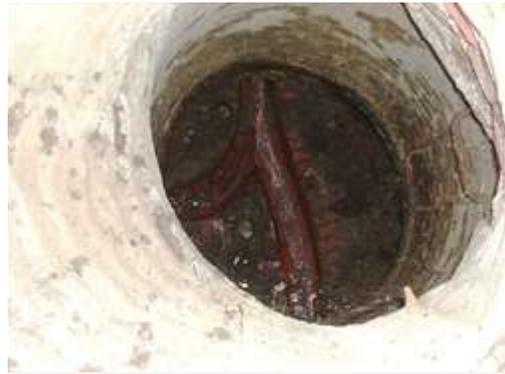
Top View

Corroded and missing steps. Evidence of surcharge - Bench debris.

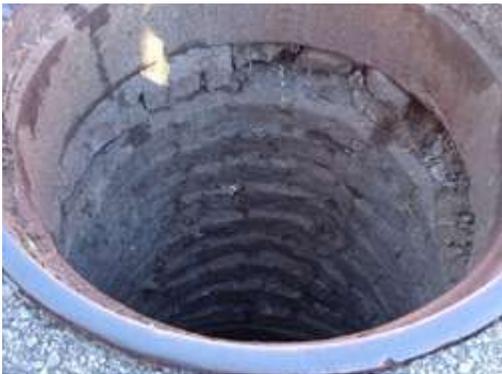
Defect

Frame leaks. Adjustment deterioration, loose bricks and infiltration. Barrel infiltration.

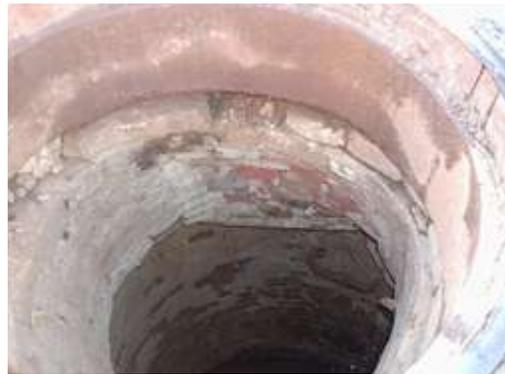
Defect

Frame leaks. Adjustment deterioration, loose bricks and infiltration. Barrel infiltration.

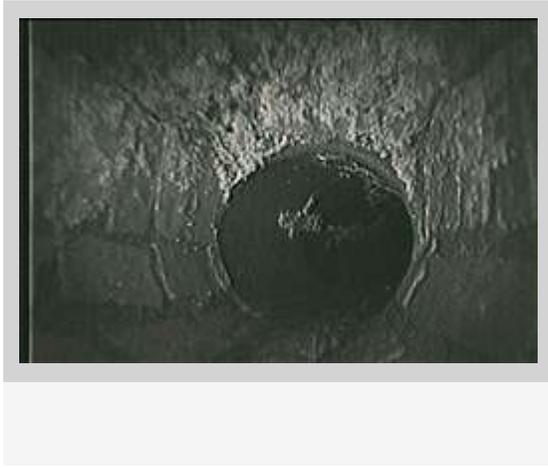
8 in. Circular Gravity Sewer
Pipe Out @ 12 O'Clock

Deposits: None Mud Sludge Debris **Grease**

Silt Depth: **0** (in.) Deposits Extent: **Light**

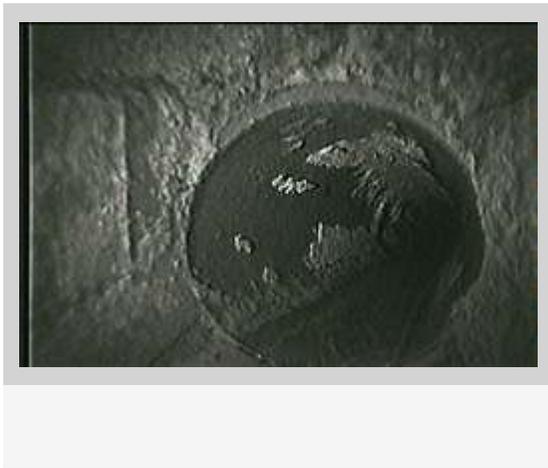
8 in. Circular Gravity Sewer
Pipe In @ 6 O'Clock

Deposits: None Mud Sludge Debris **Grease**

Infiltration: **None** Pipe Seal Cond: **Cracked**

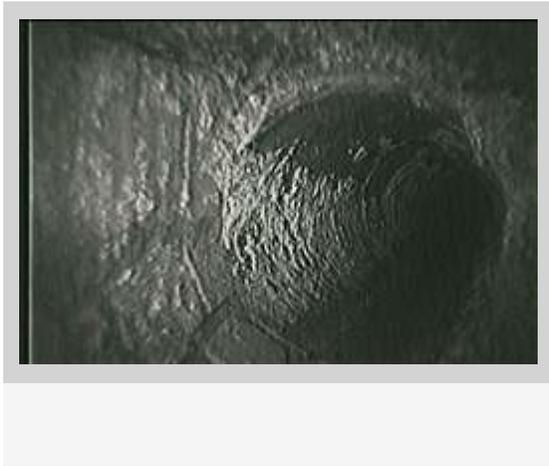
Pipe In @ 9 O'Clock

Deposits: None Mud Sludge Debris **Grease**
